VIIRS on-orbit optical anomaly – lessons learned

**SPIE Earth Observing Systems XVII
12-16 August 2012, San Diego, USA**

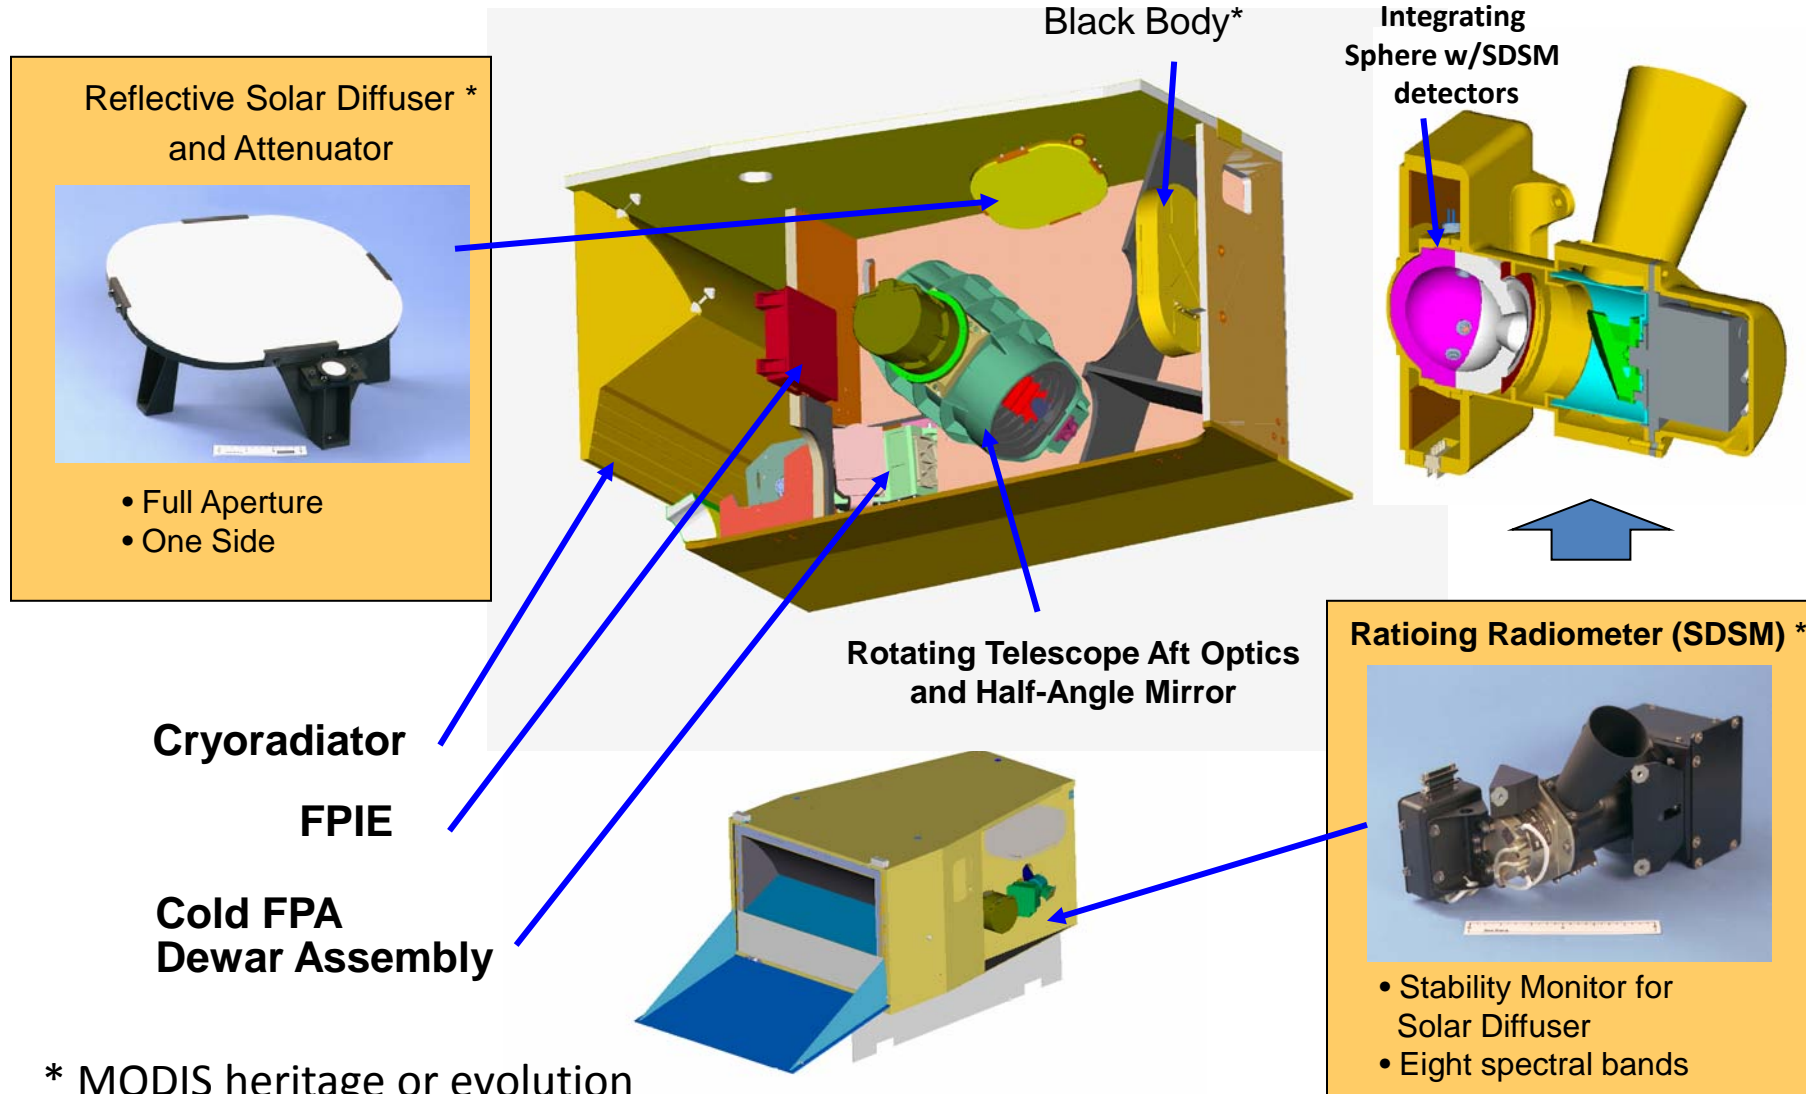
VIIRS Opto-Mechanical Module (OMM) and Solar Diffuser Stability Monitor (SDSM)

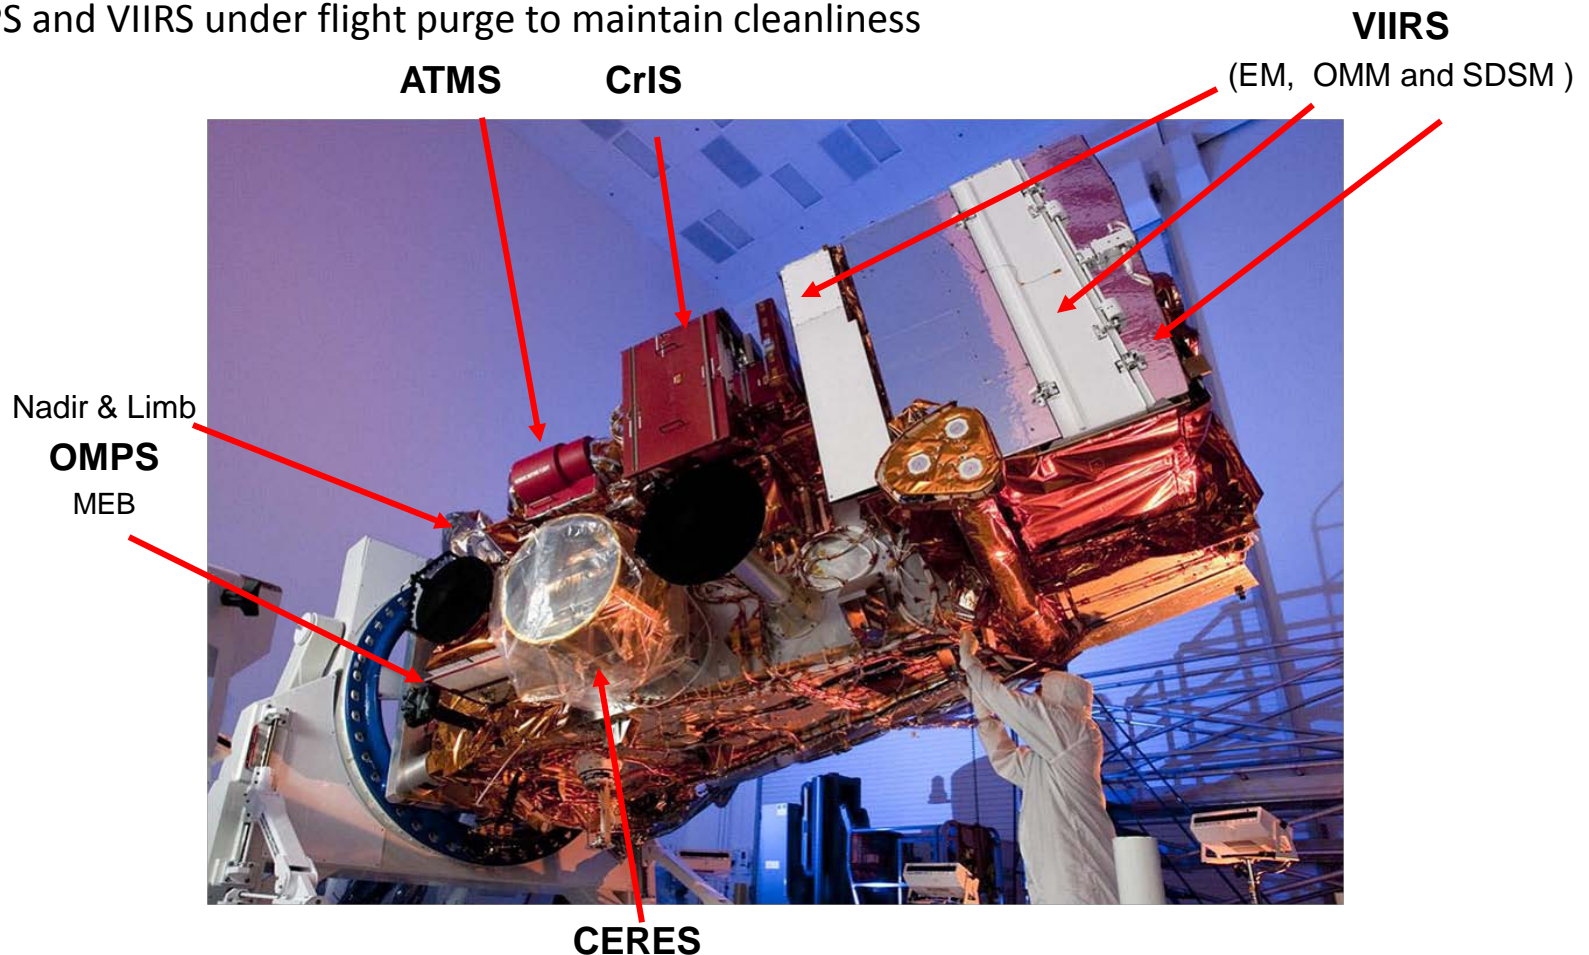
Suomi-NPP Earth Pointing Sensor Deck

- Photo from satellite in cleanroom.
- Sensors in close proximity given Nadir deck dimensions of 1.346 meters x 3.622 meters
- Remove before flight protective covers installed for ATMS and CrIS
- CERES protective bonnet installed and sensor under test purge to maintain cleanliness
- OMPS and VIIRS under flight purge to maintain cleanliness

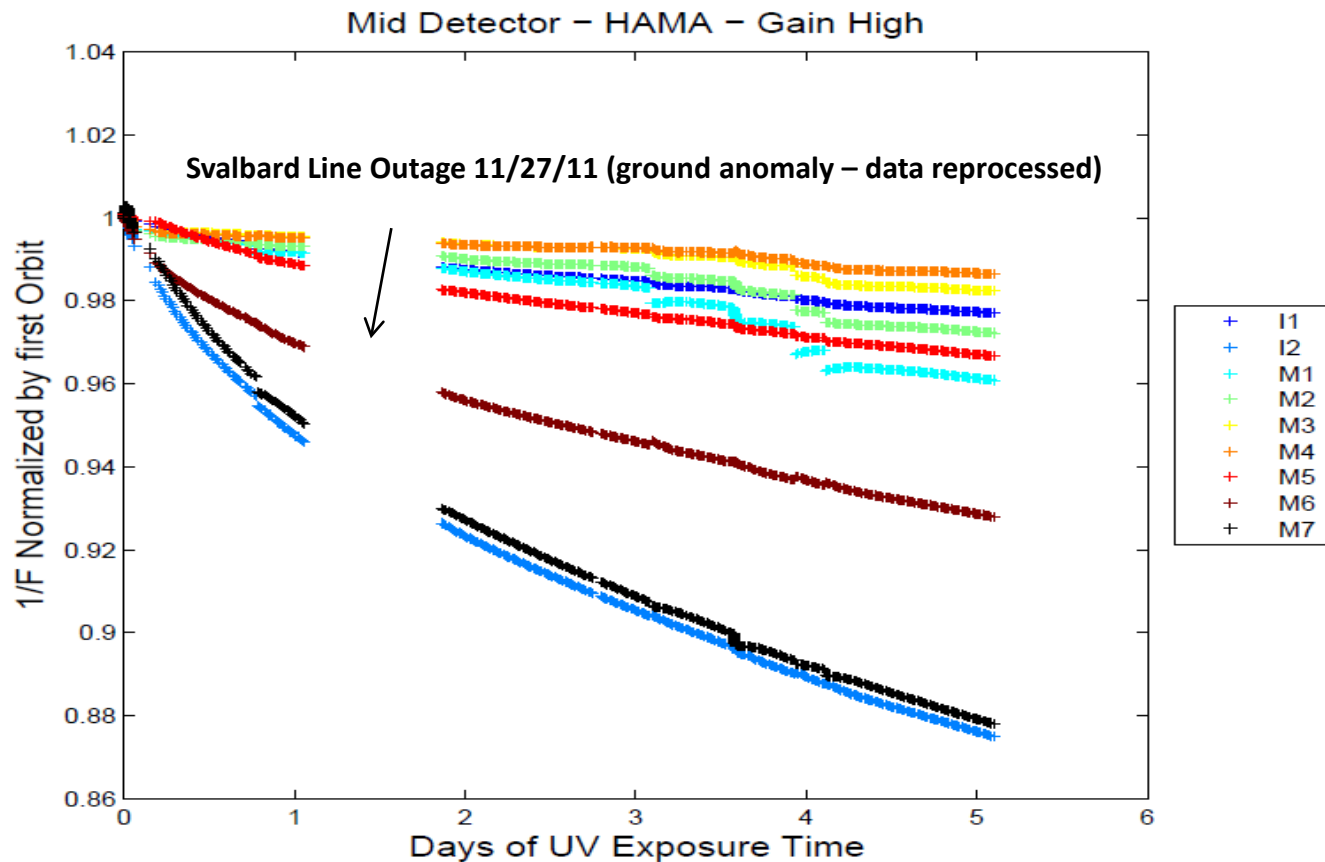
- Upon opening the SNPP VIIRS Nadir doors on-orbit, analysis of VIIRS data revealed accelerated and continued degradation of Visible/Near Infrared (VisNIR) bands throughput. The degradation was correlated with UV exposure.

- VIIRS optics are exposed to UV in earthshine is $0.5 * (124.2^\circ / 360^\circ) = 0.18$ UV day/calendar day
- For additional information refer to the “Discovery and characterization of on-orbit degradation of the Visible Infrared Imaging Radiometer Suite (VIIRS) Rotating Telescope Assembly (RTA)”, SPIE proceedings – Earth Observing Systems XVII, Session 10: VIIRS III Paper 8510-46

Degradation is measured from value first observed upon sensor activation

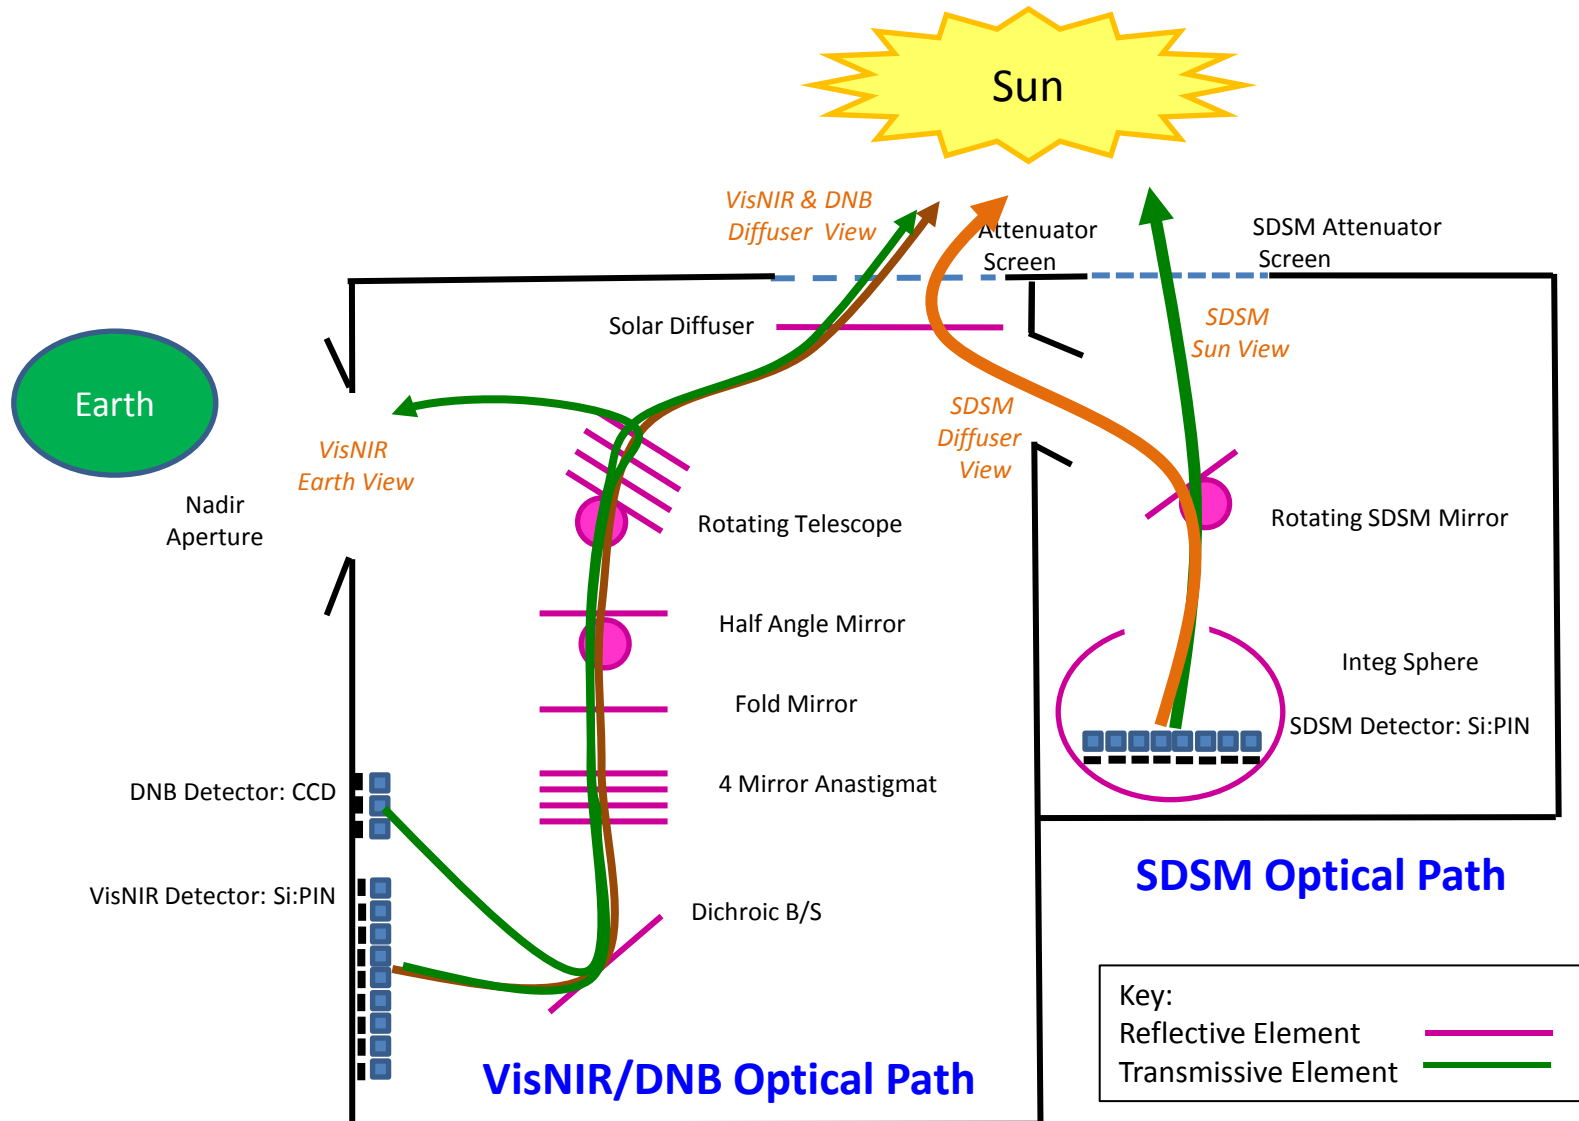
VIIRS VisNIR/DNB SDSM Optical Paths

Note: reflective elements shown as transmissive elements for simplicity

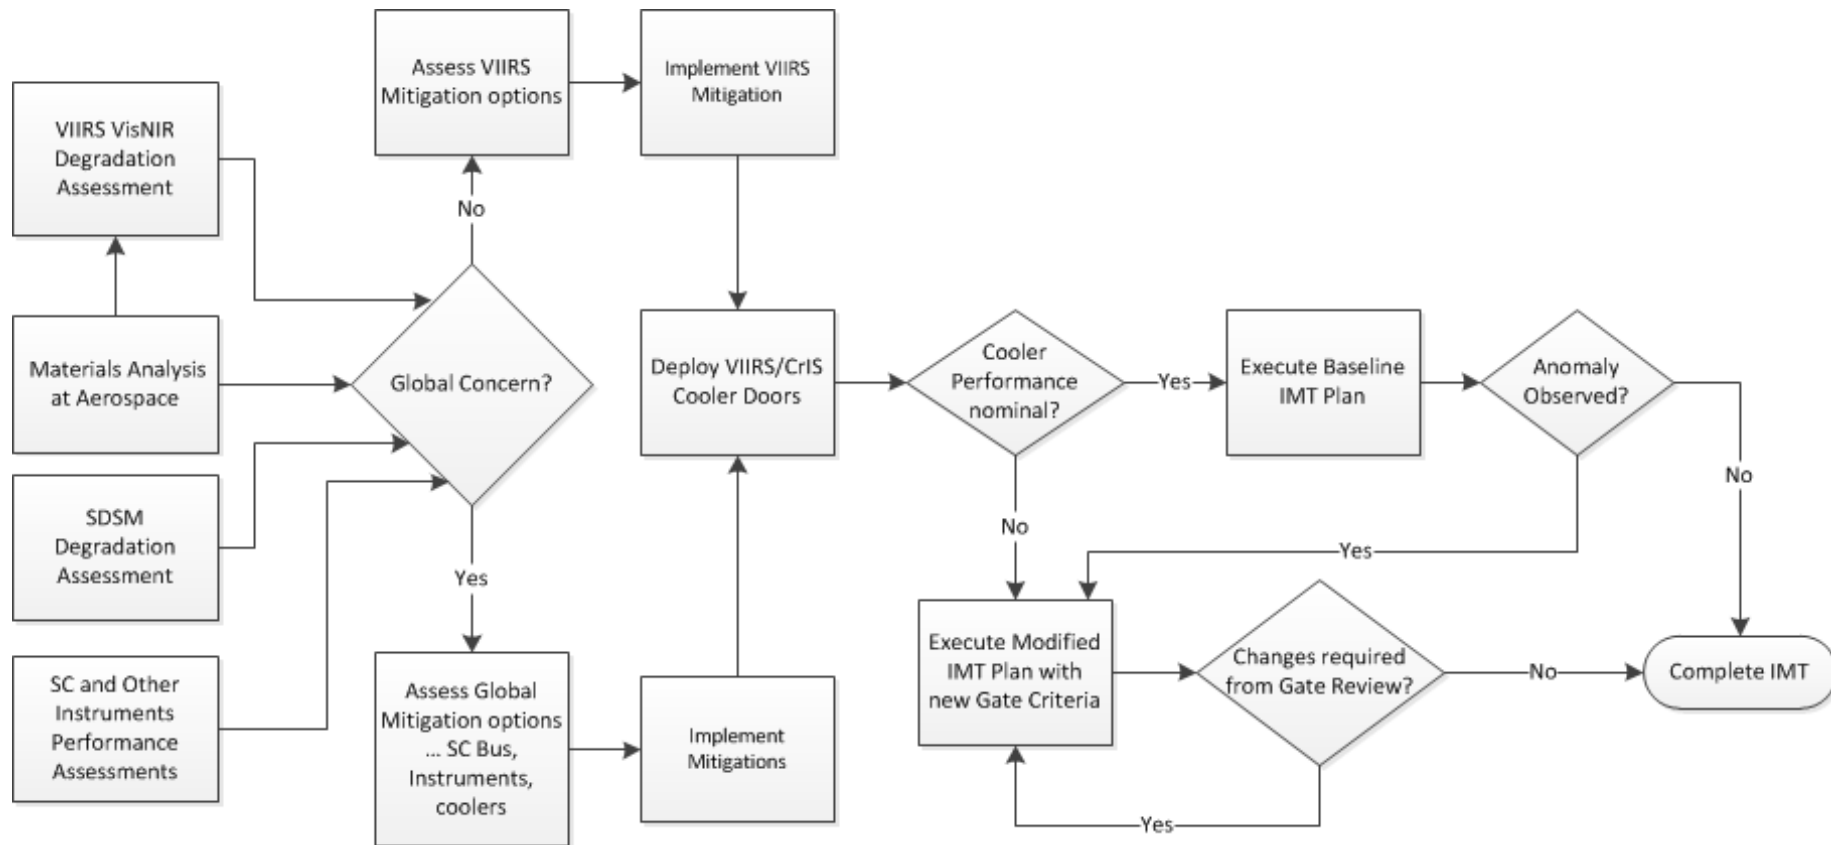
Decision process to assess commissioning risk

- The primary focus early on was to find discriminators to address the question of whether this is a localized VIIRS event or global contamination concern. In either case, could a mitigation be found or prevent further spreading or degradation.
- Once we could rationalize the risk as minimal, opening the VIIRS/CrIS cooler doors would provide key performance data to bound the risk.

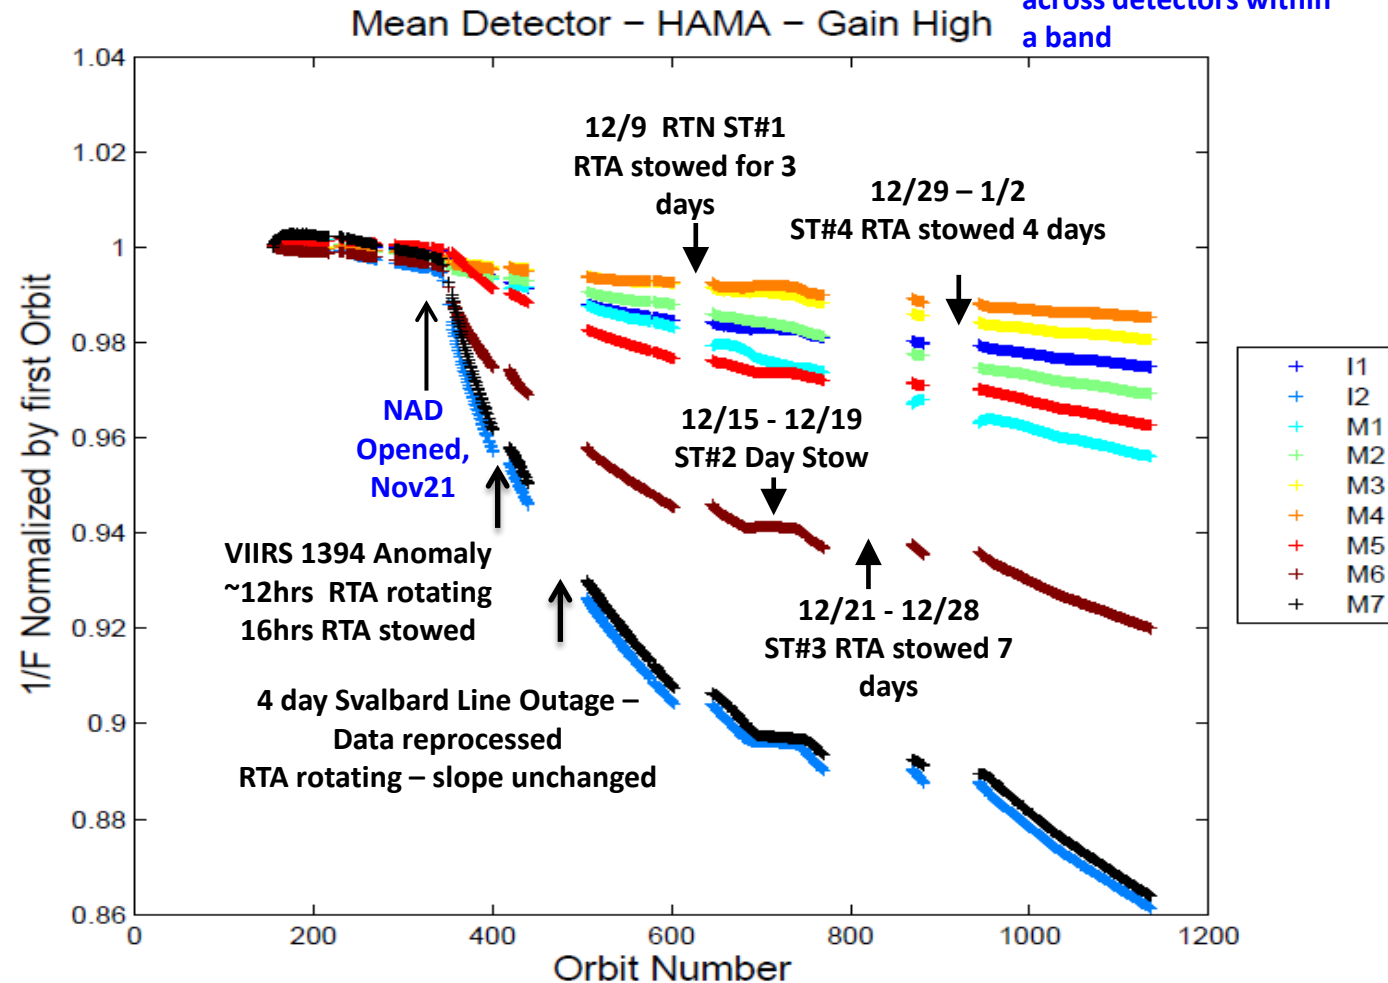
VisNIR Response vs Orbit Time Trends

Degradation is uniform across detectors within a band

- Rate of NIR response degradation significantly increased with nadir door opening. Note discontinuity in trend for NIR bands (M7/I2, M6, M5)
- NIR Degradation paused when in darkness or stowing telescope, stopping UV exposure.
- Degradation of short wavelength bands (M1-M3) relatively constant through stows and strongly correlated w/ drop in SD reflectance measured by SDSM.
- Data shows 1/F-factor for solar observations. Should be 1 for new sensor.
- VIIRS optics are exposed to UV in earthshine is $0.5 \cdot (124.2^\circ / 360^\circ) = 0.18$ UV day/calendar day

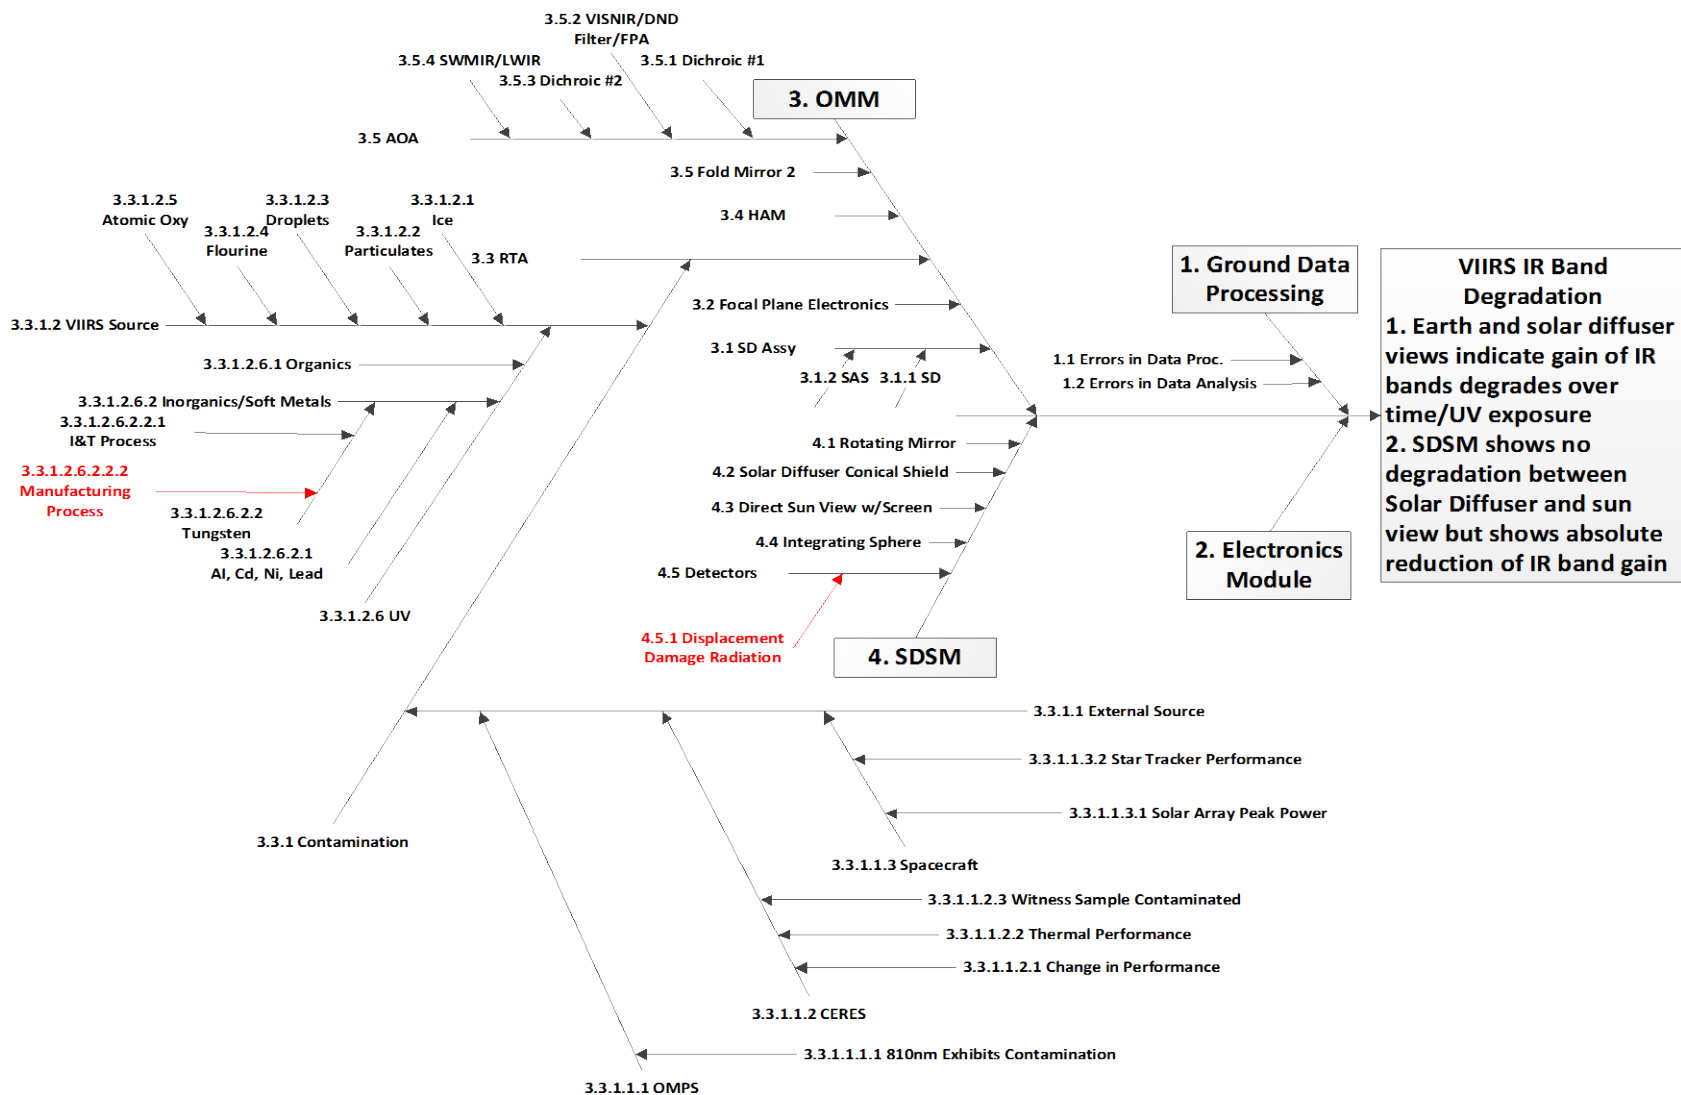
- The fishbone illustrates the various bones that were investigated to varying degrees based on what we learned incrementally through the anomaly investigation.
- The final fishbone identifies the proximate causes
 - tungsten film contamination on the VisNIR/DNB RTA mirrors and
 - displacement damage for the SDSM in Silicon PIN photodiode.
- There was a significant amount of effort expended by the team, that is not discussed in this or other papers, on how the various possible causes were discounted.

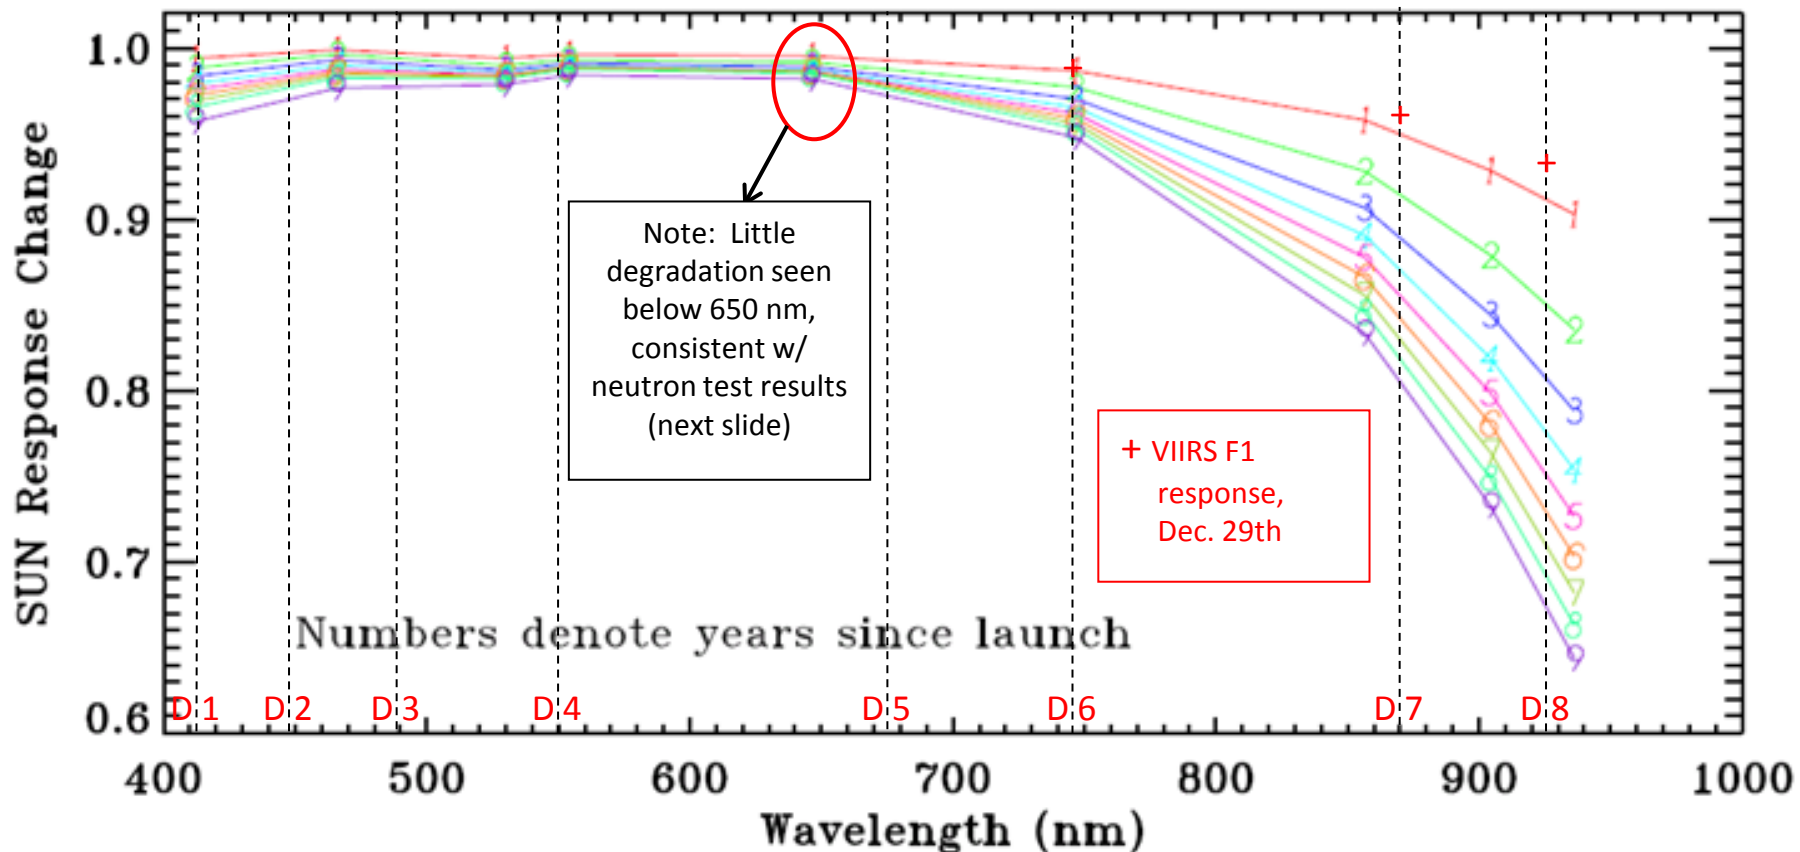
VIIRS vs MODIS Aqua SDSM Response Degradations:

- MODIS Aqua trend data courtesy of Jack Xiong and Amit Angal (MCST)
 - Similar degradation also seen for MODIS Terra
- Values for VIIRS detectors D6, D7 & D8 measured on Dec. 29th overlaid (~ 2 months since launch)
 - Est. degradation in response is <1% for D1-D5 (412-676 nm) after correction for SD degradation, not shown
- The SDSM detector vendor and part number are identical across all missions

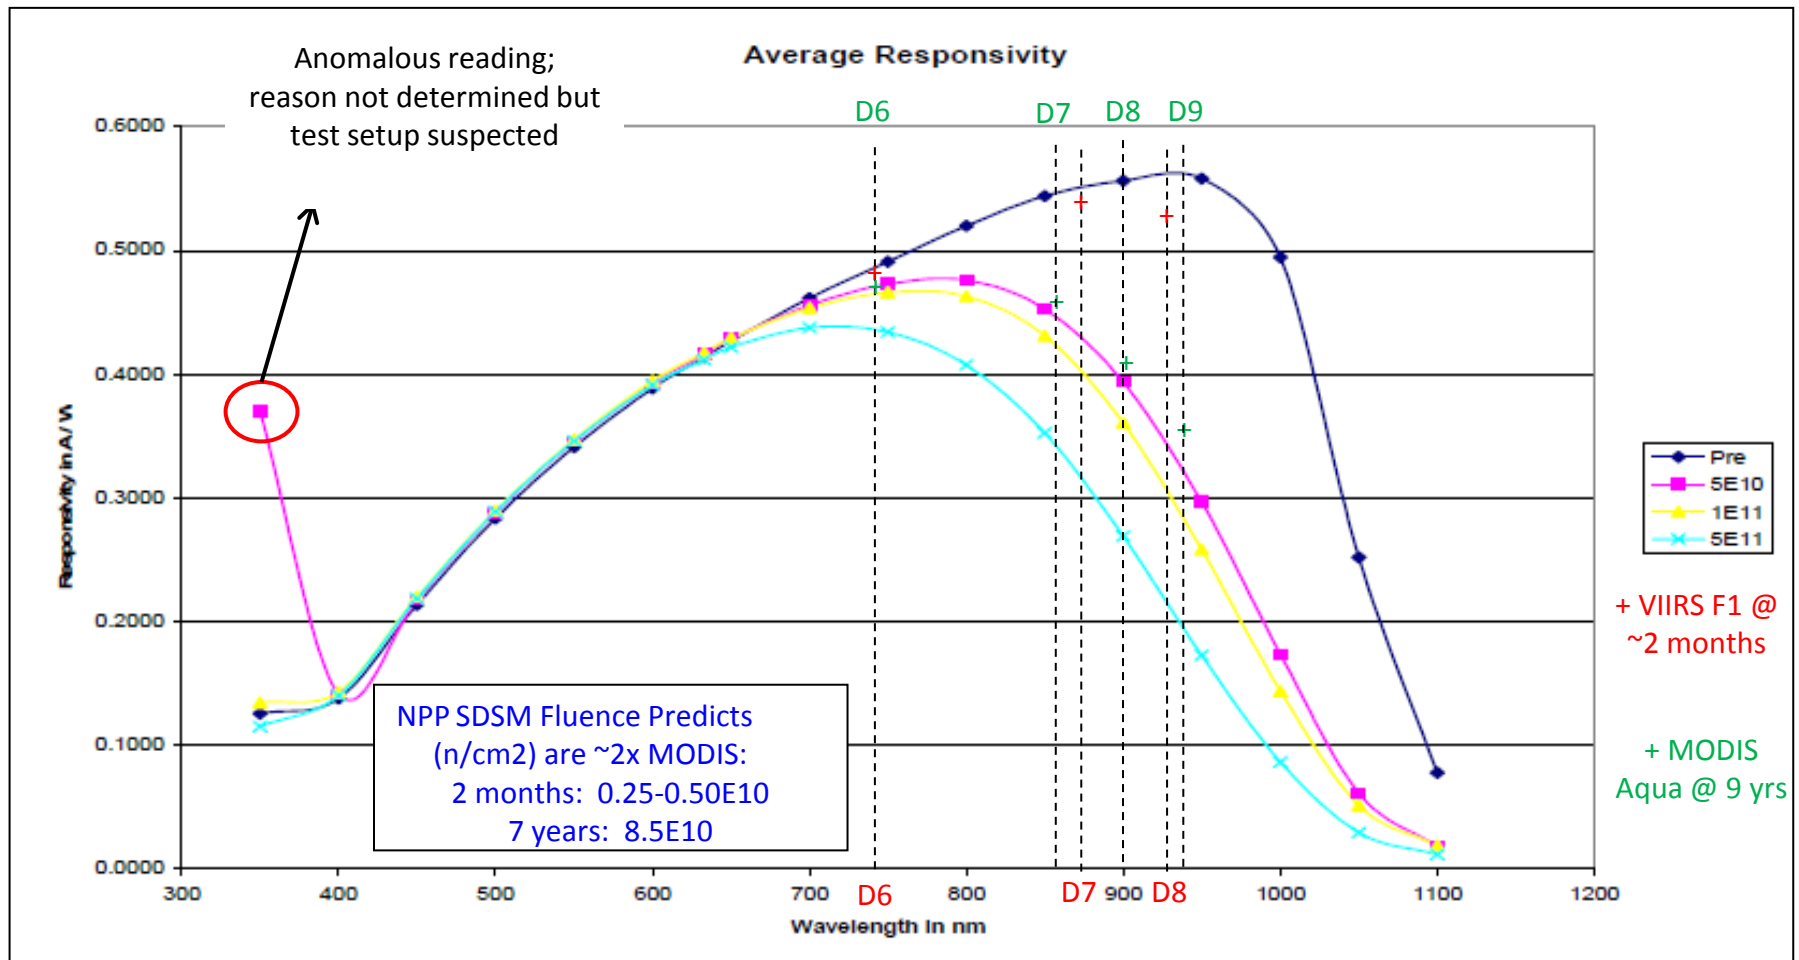
Discovery of the Smoking Guns and Root Cause Analysis (5) VIIRS & MODIS SDSM Degradation vs. Neutron Test Results

- Results provided by E. Johnson/Raytheon are for average of 4 detectors radiation tested
- Values for VIIRS D6-D8, as measured on Dec. 29th and MODIS Aqua D6-D9 @ 9 yrs overlayed on plot assuming initial on-orbit responsivity = "Pre" values
 - Est. degradation response is negligible for D1-D5 (412-676 nm) after correction for SD degradation

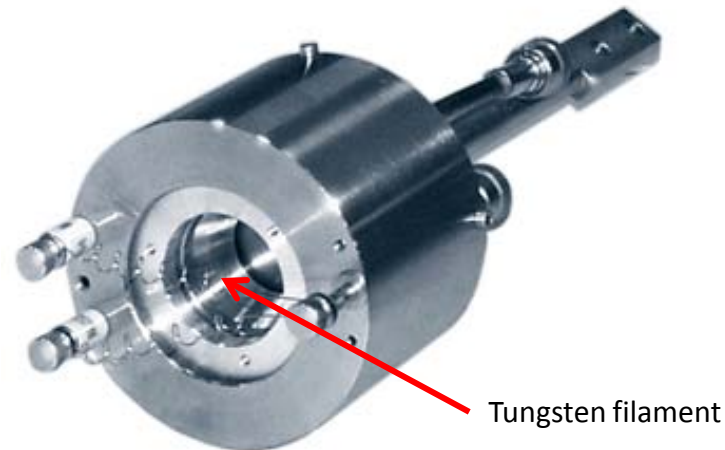
Issue Description: There was a FSS99 silver coated mirror reflection degradation issue. The root cause was determined to be Tungsten Oxide film on the surface of the FSS99 coated mirrors that was introduced after the coating was applied in an attempt to increase reflection.

- Ion gun used for substrate deposition per normal FSS99 process
- Deviation: gun used for oxygen ion bombardment to improve reflectivity

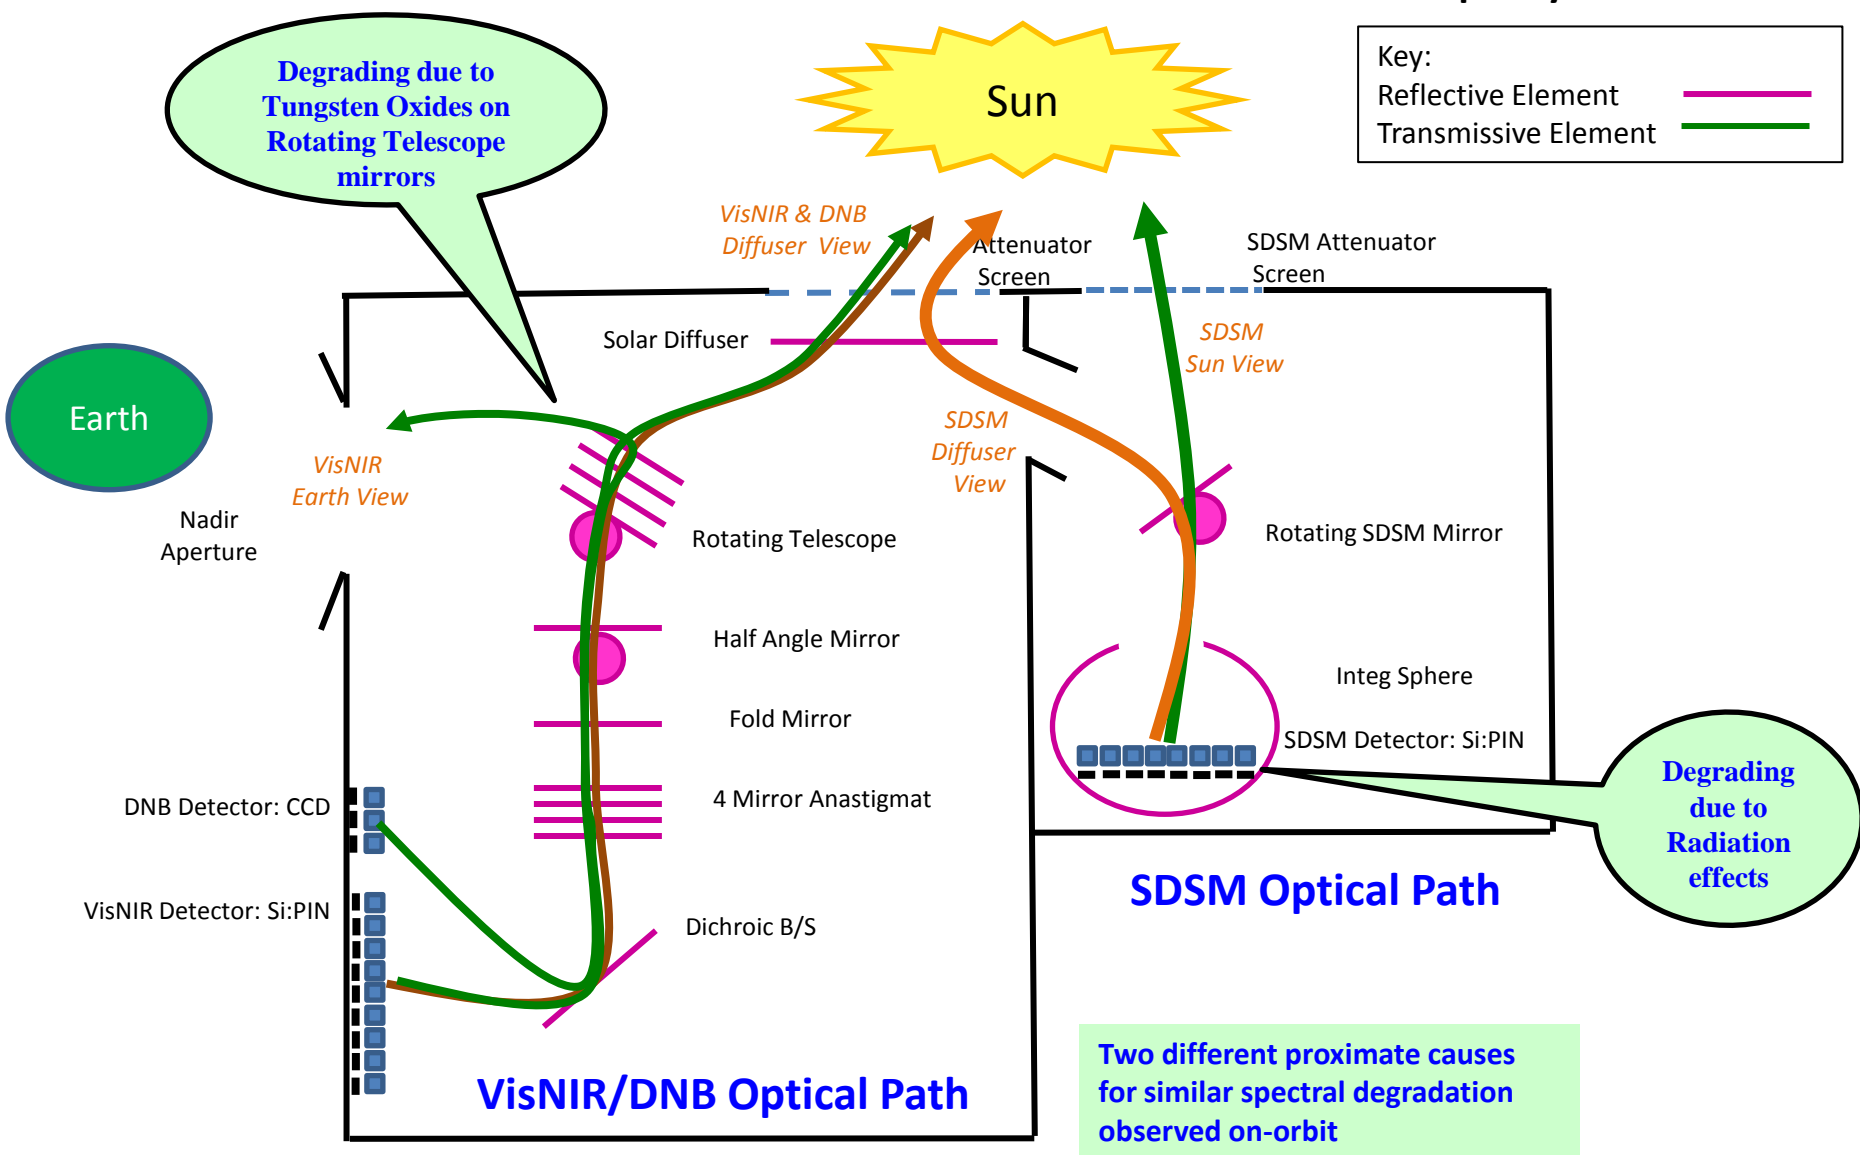
Two Proximate Causes Identified

Note: reflective elements shown as transmissive elements for simplicity

- VIIRS degradation traced to two different proximate causes
 1. VisNIR/DNB degradation was conclusively traced to the photochromic effects of tungsten on SNPP VIIRS RTA mirror surfaces. Through inspection of Denton (now Quantum) build documentation it was isolated to a 1-time process deviation (i.e. root cause) to improve surface reflectance during the mirror coating process.

- JPSS-1 VIIRS RTA mirror tested and are unaffected
 2. The VIIRS SDSM proximate cause was degradation due to displacement damage in the Silicon PIN photodiodes induced by the ~2-times radiation environment, both ionizing dose & equivalent neutron fluence, when compared to the MODIS/Aqua orbit.

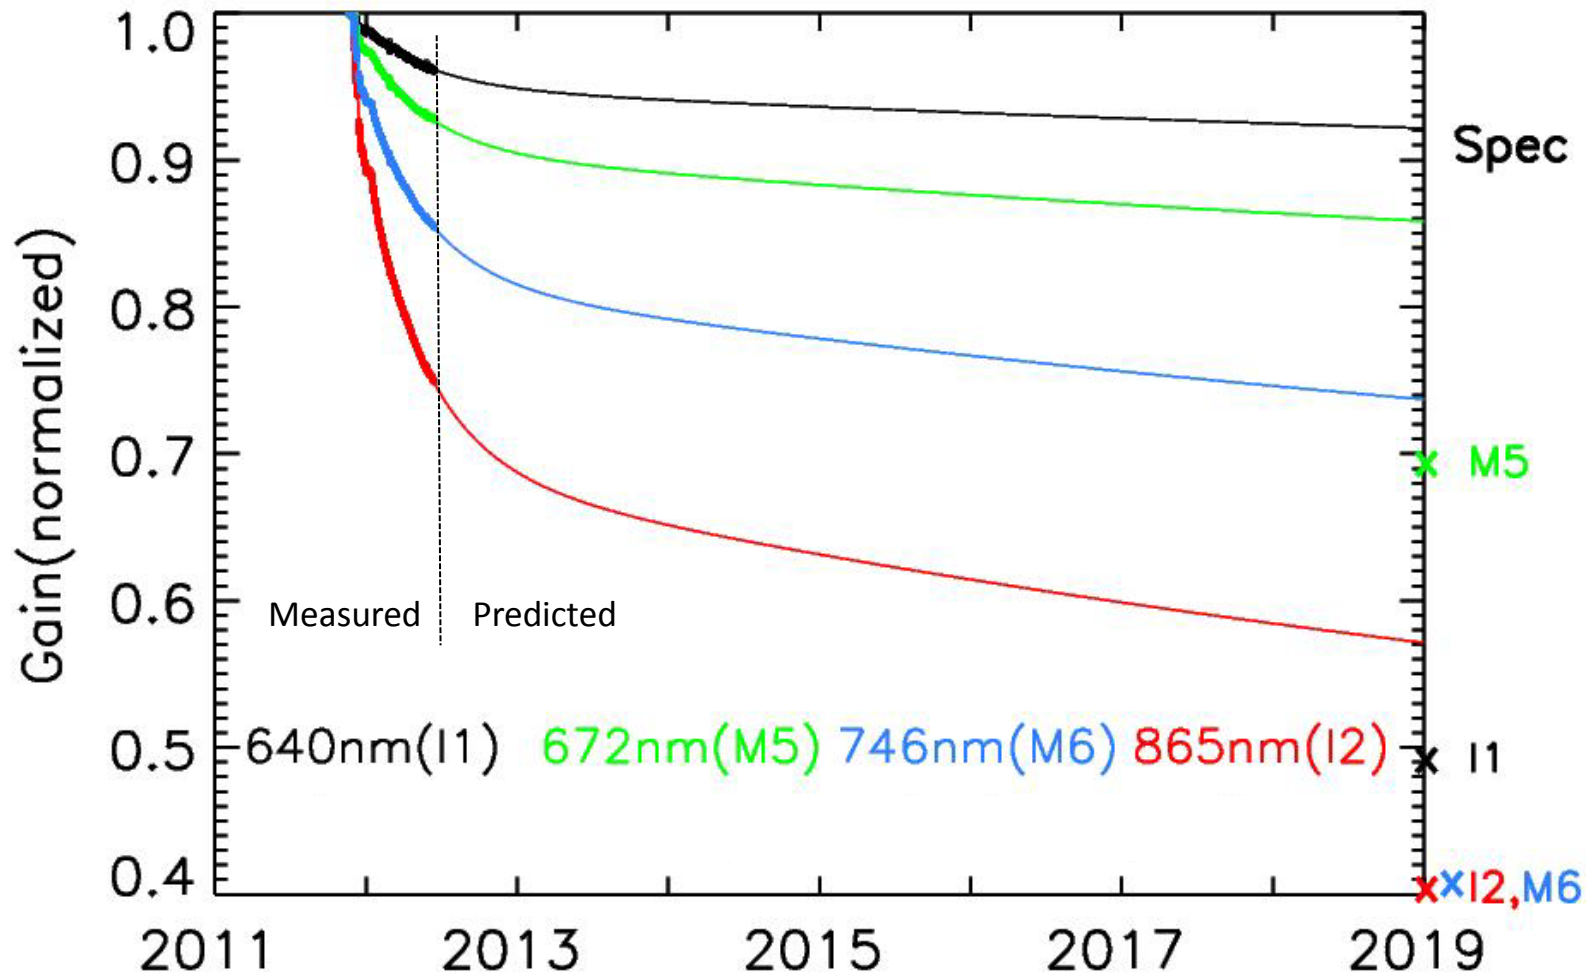
VIIRS measured and degradation prediction

Predictions all within specifications

- The Science team measured and predictions show the normalized gain will remain above specifications beyond 2019
